Ness LLC Proposal for: 7910 W. Tarp Dr. Boise, Idaho 83709

April 16, 2020

PROPOSED REMEDIATION at 7910 W. Tarp Dr. Boise, Idaho 83709

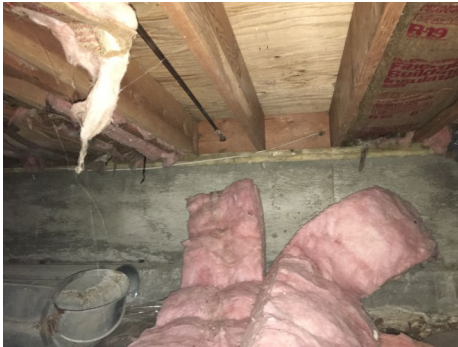
This will need to be remediated. The insulation was installed incorrectly and is falling down in a lot of areas. This will need to be removed before remediation and then replaced with R-30 insulation which is standard code in Idaho. The vapor barrier is in poor condition and needs to be replaced and pulled up onto the footings.

Mold under improperly installed insulation

Part 1: Remove R-19 Insulation from the floor decking and dispose. Total Part 1: \$1,296.32

Part 5: Install new R-30 batt insulation on the floor decking. (R-30 is code)

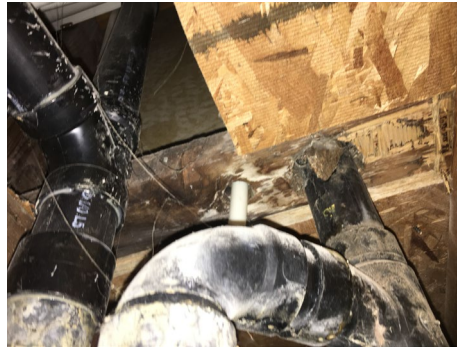
As requested, the crawlspace and attic were inspected for water damage and mold. There does not appear to be any drainage issues, at this time. This is not a guarantee that there cannot be future water intrusion if conditions change. There appears to be sporadic mold throughout the crawlspace on the rim joist, floor decking, floor joists, and the area under the bath tub where there was a previous leak.

Mold under previous bath tub leak

1. After containment is set up, surface cleaning and abrasive removal will be performed, as needed, of visible microbial growth on the impacted areas. Once mold impacted surfaces are cleaned, then treat the remediated surfaces in the crawlspace with a non-toxic Microbial Growth Inhibitor.
2. (1) Procedures are established from IICRC S520 Standard and Reference Guide for Professional Mold Remediation. (2) All work in the crawlspace will be performed using accepted procedures. (3) Respiratory Protection is in accordance with the OSHA respiratory protection standard (29 CFR 1910.134) for the remediation. Gloves, full-face respirators, p-100 particulate filters, Tyvek full body suits with hoods and boots.
3. Photo documentation of work performed is available at the end of the project upon prior request. Disposal of debris.

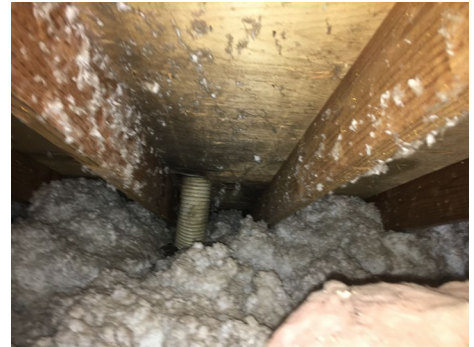
As for the attic, there appears to be sporadic microbial growth on the roof sheathing and top cords. The bath fan and laundry room fan need to be connected to roof jacks so they are venting properly to the exterior.

Mold in attic where duct is not properly vented.

1. After containment is set up, surface cleaning and abrasive removal will be performed, as needed, of visible microbial growth on the impacted roof sheathing and top cords. Once mold impacted surfaces are cleaned, then treat the remediated surfaces in the attic with a non-toxic Microbial Growth Inhibitor.
2. (1) Procedures are established from IICRC S520 Standard and Reference Guide for Professional Mold Remediation. (2) All work in the attic will be performed using accepted procedures. (3) Respiratory Protection is in accordance with the OSHA respiratory protection standard (29 CFR 1910.134) for the remediation. Gloves, full-face respirators, p-100 particulate filters, Tyvek full body suits with hoods and boots.
3. Photo documentation of work performed is available at the end of the project upon prior request. Disposal of debris.

1. Install two roof jacks
2. Connect bath fan duct and laundry room duct to roof jacks.
3. Seal penetrations.
