Ness LLC Proposal for: 1887 N. Moon Bellow Way Eagle, Idaho 83616

April 20, 2020

PROPOSED WATER DRAINAGE for the Crawlspace at 1887 N. Moon Bellow Way Eagle, Idaho

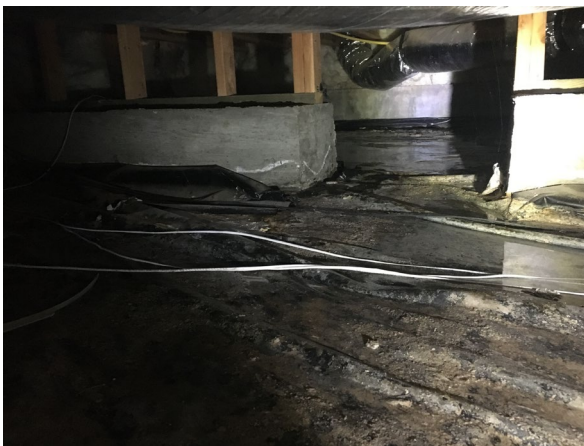
As requested, we inspected the crawlspace for standing water. Based on the visual evidence that there is a history of the water intrusion, a partial drain system is recommended in the right side of the crawlspace. This is not a guarantee that there cannot be future intrusion in other areas as conditions change. We did observe an active leak in the crawlspace that appears to be coming from a refrigerator line. This will need to be repaired by a licensed professional to keep our warranty valid. There did not appear to be any visible microbial growth, at this time, but the view was limited due to standing water in some areas. If any microbial growth is discovered, while the recommended work is performed, you will be informed immediately and a bid will be provided for remediation.

Standing water on top of the vapor barrier

1. Install a fabric lined graded drain system below the bottom of the footings along the interior perimeter of the crawlspace in the far right-side bay.
2. Drain in crawlspace will collect into a sump tank located in the right side of the crawlspace.

Part 3: Install sump pump into tank with insulated lid in the appropriate determined area. Sump will discharge line will be connected to the downspout on the back right corner of the house. (The sump pump discharge line will not be visible from the outside of the house. Installation of electrical outlet with audible alarm and manual shut-off included.)

Part 4: Remove and dispose of old vapor barrier, miscellaneous debris, and building materials in the right bay where the system will be installed. Install new 6 mil. vapor barrier, where removed, and pull up onto the footings, where possible. **ADD to Total = \$568.31**

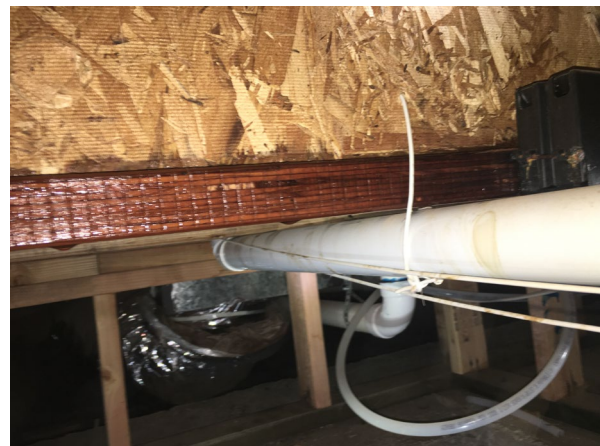
Active leak from refrigerator
