Ness LLC Proposal for: 1531 N. Triathlon Ave. Eagle, Idaho 83616

July 2, 2020

PROPOSED WATER DRAINAGE for the crawspace at 1531 N. Triathlon Ave. Eagle, Idaho 83616

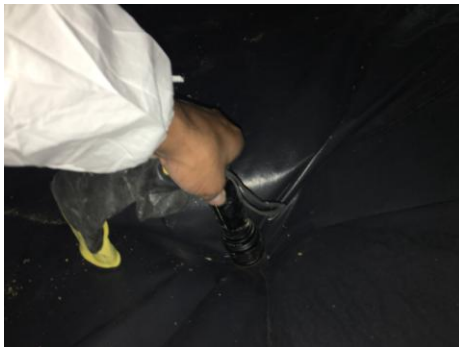
As requested, we inspected the crawspace for standing water. At the time of our inspection, there was almost a foot of water in most of the crawspace. We would recommend a drain system with two pumps. There did not appear to be any visible mold but the view was very limited. If anything is observed during the drain installation, we will contact you immediately and provide a bid for remediation. The vapor barrier is in good condition so we'll cut and pull it back from the footing to install the system and then install an apron on the perimeter above the trenches. There is some insulation on the bottom of the stem walls that is wet/damaged. We will cut and remove the bottom of the insulation (approx. 6") that is damaged. Core will need to evaluate the insulation when the project is completed and replace as needed.

standing water under vapor barrier

1. Install a fabric lined graded drain system below the bottom of the footings on the entire perimeter of the crawspace.
2. Drain in crawspace will collect into 2 sump tanks. The 1 tank will be in the mid-left side of the crawspace and the other tank in the mid-right side.

Part 3: Install 2 sump pumps into 2 tanks with insulated lids in the appropriate determined areas. Sumps will discharge through a drain line towards a dispersal bed in the front left landscaped area. (The sump pump discharge line will not be visible from the outside of the house. Installation of electrical outlet with audible alarm and manual shut-off included.)

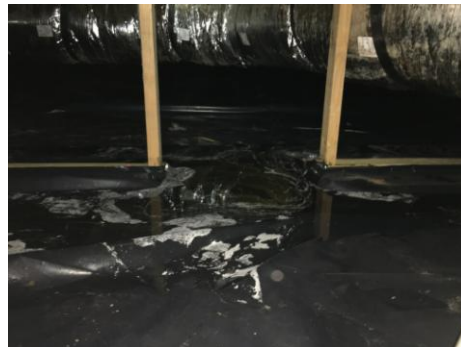
actively moving water on top of plastic

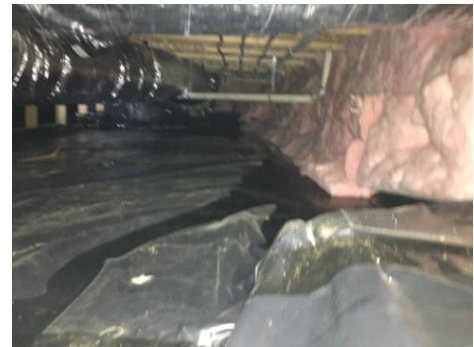
saturated insulation

Part 4: Remove and dispose of miscellaneous debris, damaged insulation and building materials. Install new 6 mil. vapor barrier apron in the entire perimeter of the crawlspace above the trenches and pull up onto the footings, where possible. Seams will be taped per code for a conditioned crawlspace. **Part 4 ADD to Total = \$ 545.6**
