# Ness LLC

**Ness LLC Proposal for:** 2875 Elisha Ave. Meridian, Idaho 83646

**October 23, 2020**

**PROPOSED WATER DRAINAGE/REMEDIATION for the crawlspace at 2875 Elisha Ave. Meridian, Idaho 83646**  
**Ness, LLC is an IICRC council certified Mold Remediation Contractor, licensed, bonded, and insured with mold and environmental pollution endorsements**

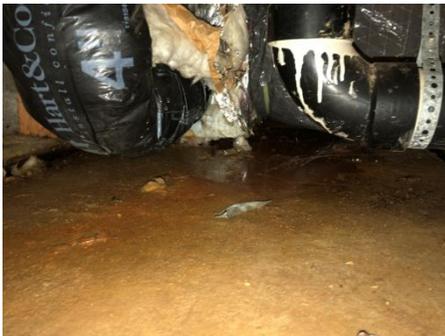
As requested, the crawlspace was inspected for standing water. There is an existing pump that does not appear to be functional as there was standing water in various areas and visible history of water intrusion. Ness would recommend cancelling the current pump and installing a drain system on the entire interior perimeter of the crawlspace. We also observed a pony wall behind the garage that is water damaged and tilted. This will need to be repaired/re-secured and mold remediation will be required. The vapor barrier will need to be replaced and we will re-secure fallen insulation and install new batts, where needed. Our inspector also noted that the furnace is leaking into the crawlspace. We recommend the owner consult an HVAC professional for repair or our warranties could be voided.

water in crawl under furnace

1. All access to crawlspace surfaces will be protected by plastic sheeting during work.
2. Preliminary digging and pumping to remove excess water, as needed.
3. Negative air machine used for the crawlspace during work and for dry down.
4. Additional fans will be installed for dry down, as needed.
5. Clear foundation vents of any insulation that may be blocking air flow.

1. Cancel and remove existing drain system.
2. Install a fabric lined graded drain system below the bottom of the footings on the entire perimeter of the crawlspace except for part of the area behind the garage.
3. Drain in crawlspace will collect into a sump tank. The sump tank will be in the mid-left side of the crawlspace.

**Part 3:** Install sump pump into tank with insulated lid in the appropriate determined area. Sump will discharge through a drain line to a dispersal bed towards a landscaped area that will be determined onsite. (The sump pump discharge line will not be visible from the outside of the house. Installation of electrical outlet with audible alarm and manual shut-off included.)

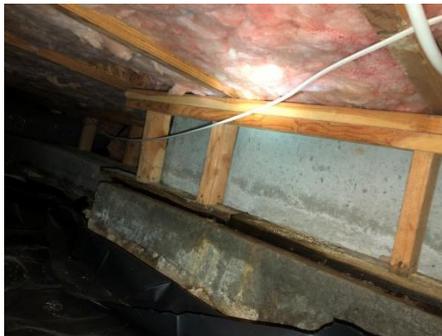
water damaged pony wall-front view

1. After containment is set up, then perform surface cleaning and abrasive removal, as needed, of visible microbial growth on the impacted pony wall and surrounding supports. (1) Once mold impacted surfaces are cleaned, then treat the remediated surfaces in the crawlspace with a non-toxic Microbial Growth Inhibitor. Procedures are established from IICRC S520 Standard and Reference Guide for Professional Mold Remediation. (2) All work in the crawlspace will be performed using accepted procedures. (3) Respiratory Protection is in accordance with the OSHA respiratory protection standard (29 CFR 1910.134) for the remediation. Gloves, full-face respirators, p-100 particulate filters, Tyvek full body suits with hoods and boots. Photo documentation of work performed is available at the end of the project upon prior request. Disposal of debris.

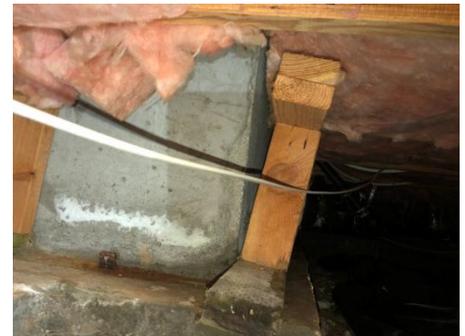
water damaged pony wall- side view- tilted
