**Ness LLC Proposal for:** 2875 N. Elisha Ave. Meridian, Idaho 83646

**PROPOSED WATER DRAINAGE/REMEDIATION for the crawlspace at 2875 N. Elisha Ave. Meridian, Idaho 83646**  
**Ness, LLC is an IICRC council certified Mold Remediation Contractor, licensed, bonded, and insured with mold and environmental pollution endorsements**

As requested, the crawlspace was inspected for standing water. There is an existing pump that does not appear to be functional as there was standing water in various areas and visible history of water intrusion. Ness would recommend cancelling the current pump and installing a drain system on the entire interior perimeter of the crawlspace. We also observed a pony wall behind the garage that is water damaged and tilted. This will need to be repaired/re-secured and mold remediation will be required. The vapor barrier will need to be replaced and we will re-secure fallen insulation and install new batts, where needed. Our inspector also noted that the furnace is leaking into the crawlspace. We recommend the owner consult an HVAC professional for repair or our warranties could be voided.

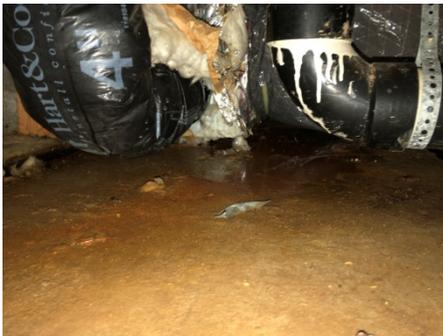
water in crawl under furnace

1. Cancel and remove existing drain system.
2. Install a fabric lined graded drain system below the bottom of the footings on the entire perimeter of the crawlspace except for part of the area behind the garage.
3. Drain in crawlspace will collect into a sump tank. The sump tank will be in the mid-left side of the crawlspace.

**Part 3:** Install sump pump into tank with insulated lid in the appropriate determined area. Sump will discharge through a drain line to a dispersal bed towards a landscaped area that will be determined onsite. (The sump pump discharge line will not be visible from the outside of the house. Installation of electrical outlet with audible alarm and manual shut-off included.)

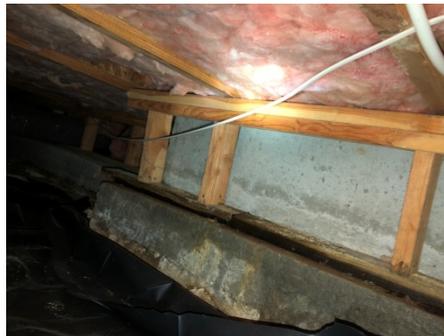
water damaged pony wall-front view

1. After containment is set up, then perform surface cleaning and abrasive removal, as needed, of visible microbial growth on the impacted pony wall and surrounding supports. (1) Once mold impacted surfaces are cleaned, then treat the remediated surfaces in the crawlspace with a non-toxic Microbial Growth Inhibitor. Procedures are established from IICRC S520 Standard and Reference Guide for Professional Mold Remediation. (2) All work in the crawlspace will be performed using accepted procedures. (3) Respiratory Protection is in accordance with the OSHA respiratory protection standard (29 CFR 1910.134) for the remediation. Gloves, full-face respirators, p-100 particulate filters, Tyvek full body suits with hoods and boots. Photo documentation of work performed is available at the end of the project upon prior request. Disposal of debris.

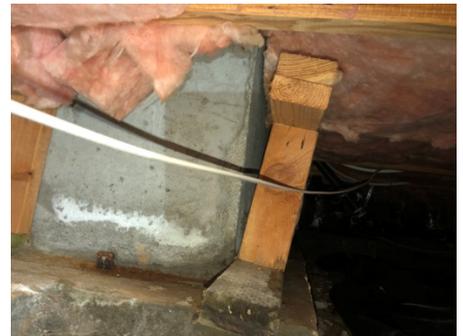
water damaged pony wall- side view- tilted
