# Ness LLC

**Ness LLC Proposal for:** 4445 N. Price Ave. Meridian, Idaho

## RESTORATION PROPOSAL for the Attic at 4445 N. Price Ave. Meridian, Idaho

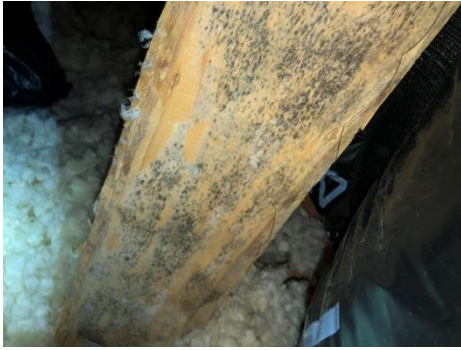
As requested, the attic, crawlspace and north side of the home was inspected for mold. Remediation will be necessary in the attic as there appears to be sporadic microbial growth throughout the upper and lower attics on the king posts, brace supports, and top cords. There did not appear to be enough visible history of water intrusion in the crawlspace to warrant a drain system, at this time. There also did not appear to be any visible mold in the areas that we inspected. However, we do recommend removing debris from the crawlspace and replacing the vapor barrier as it is in poor condition.

visible mold in attic

1. After containment is set up, perform surface cleaning and abrasive removal as needed of visible microbial growth on the before mentioned affected areas. Once mold impacted surfaces are cleaned then, treat the remediated surfaces in the attics with a non-toxic Microbial Growth Inhibitor.
2. (1) Procedures are established from IICRC S520 Standard and Reference Guide for Professional Mold Remediation. (2) All work in the attics will be performed using accepted procedures. (3) Respiratory Protection is in accordance with the OSHA respiratory protection standard (29 CFR 1910.134) for the remediation. Gloves, full-face respirators, p-100 particulate filters, Tyvek full body suits with hoods and boots.
3. Photo documentation of work performed is available at the end of the project upon request previous to the start of the project.
4. Disposal of debris.

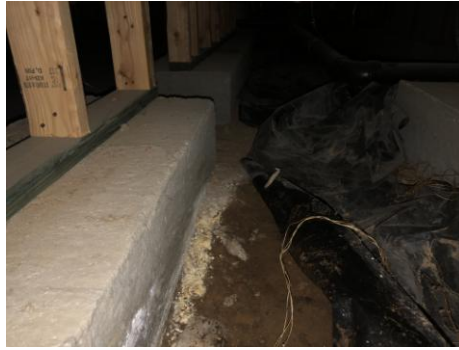
damaged plastic-not pulled up on footing

1. Remove and dispose of old vapor barrier, miscellaneous debris, and building materials. Install new 6 mil. plastic in the entire crawlspace and pull up onto the footings, where possible.
2. Re-secure fallen insulation
3. Clear foundation vents of any debris or insulation that may be blocking air flow.

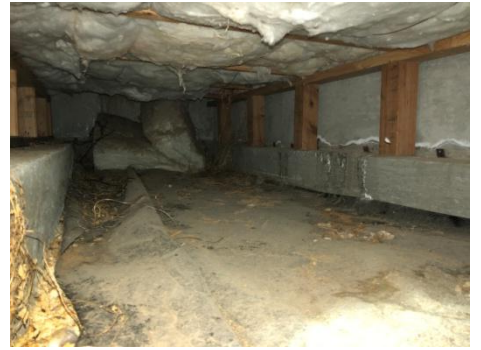
debris in crawl and hanging insulation
