**Ness LLC Proposal for:** 4445 N. Price Ave. Meridian, Idaho

## **RESTORATION PROPOSAL for the Attic at 4445 N. Price Ave. Meridian, Idaho**

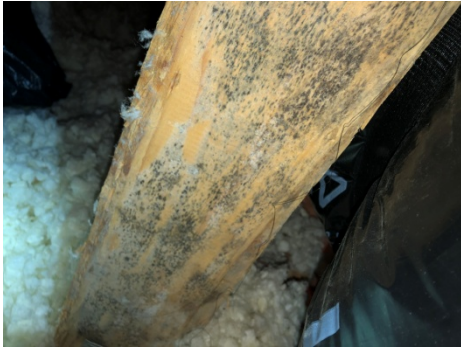
As requested, the attic, crawlspace and north side of the home was inspected for mold. Remediation will be necessary in the attic as there appears to be sporadic microbial growth throughout the upper and lower attics on the king posts, brace supports, and top cords. There did not appear to be enough visible history of water intrusion in the crawlspace to warrant a drain system, at this time. There also did not appear to be any visible mold in the areas that we inspected. However, we do recommend removing debris from the crawlspace and replacing the vapor barrier as it is in poor condition.

visible mold in attic

1. All access to the attics will be protected during work.
2. The furnace system is to remain off during the work and for 3 hours after each treatment.
3. Establish negative air flow. This will be ongoing while the work is performed.
4. Surface cleaning and abrasion removal, as needed and treat impacted king posts, brace supports, and top cords. **(See Part 2)**
5. The furnace system is to remain off during the work and for 3 hours after each treatment.
6. Seal all penetrations that are accessible.

1. After containment is set up, perform surface cleaning and abrasive removal as needed of visible microbial growth on the before mentioned affected areas. Once mold impacted surfaces are cleaned then, treat the remediated surfaces in the attics with a non-toxic Microbial Growth Inhibitor.
2. (1) Procedures are established from IICRC S520 Standard and Reference Guide for Professional Mold Remediation. (2) All work in the attics will be performed using accepted procedures. (3) Respiratory Protection is in accordance with the OSHA respiratory protection standard (29 CFR 1910.134) for the remediation. Gloves, full-face respirators, p-100 particulate filters, Tyvek full body suits with hoods and boots.
3. Photo documentation of work performed is available at the end of the project upon request previous to the start of the project.
4. Disposal of debris.

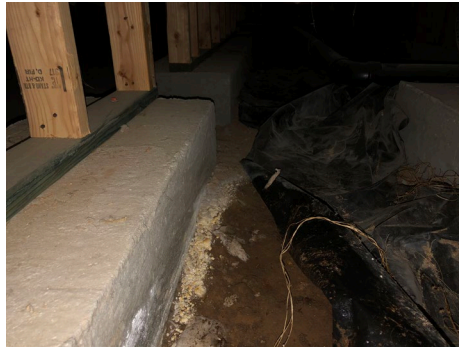
damaged plastic-not pulled up on footing

1. Remove and dispose of old vapor barrier, miscellaneous debris, and building materials. Install new 6 mil. plastic in the entire crawlspace and pull up onto the footings, where possible.
2. Re-secure fallen insulation
3. Clear foundation vents of any debris or insulation that may be blocking air flow.

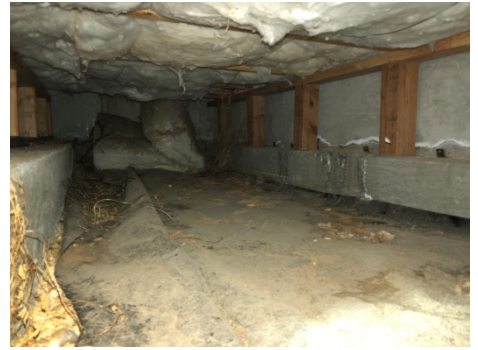
debris in crawl and hanging insulation
