Ness LLC

1-20-2021

PROPOSED DRY DOWN at 1419 N. Honalee Ave. Eagle, Idaho 83616 (Legacy 04-18)

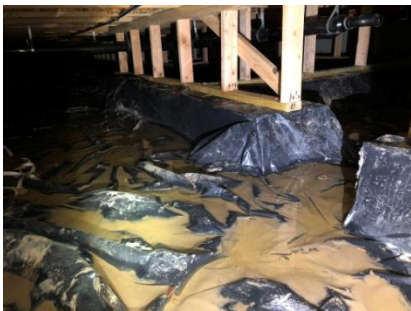
As requested, the crawlspace was inspected for standing water. There is seasonal water intrusion throughout most of the crawlspace so we would recommend installing a drain system with 2 pumps. However, we have been instructed to provide a proposal to de-water and dry out the crawlspace. Please see Part 1 below. If the water returns after we pump it out, then it would appear that, there are additional water sources that are contributing to the water intrusion and a drain system will be required to control the seepage/flow. We would then cease all work, at that time, payment for Part 1 will be due, and a proposal will be written up for a drain system as originally recommended.

Standing water in the crawlspace

Part 1: Dewater and Dry Down. (This is not a guarantee that there cannot be future water intrusion)

1. All access to crawlspace surfaces will be protected by plastic sheeting during work.
2. Preliminary digging and pumping to remove excess water.
3. Negative air machine will be used for the crawlspace; Ness will install up to 9 fans for 10-14 days for dry down.
4. Set dehumidifier(s), as needed.
5. If the water returns, after it is pumped out, all equipment will be removed, payment for Part 1 will be due and a bid for a drain system will be provided. Please note: failure to control the water may impact our warranty for mold remediation.

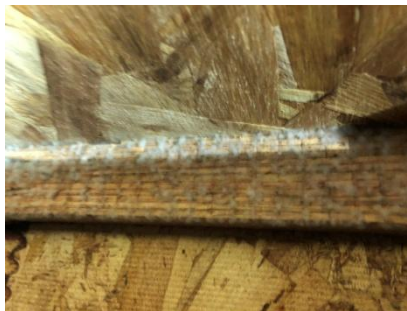
In addition, there appears to be sporadic microbial growth throughout the crawlspace on the floor decking and the top cords of the floor joists. This will need to be remediated per IICRC guidelines. After remediation, the vapor barrier will need to be replaced.

Microbial growth on top cord of floor joist

1. After containment is set up, then perform surface cleaning and abrasive removal, as needed, of visible microbial growth on the impacted floor decking and top cords of the floor joists. Once all visible mold is removed from impacted surfaces and inspected then do the final treatment of the remediated surfaces in the crawlspace with a non-toxic Microbial Growth inhibitor.)

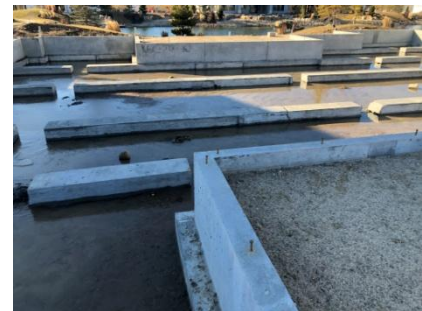
Adjacent property showing standing water
