Ness LLC Proposal for: 2875 Elisha Ave. Meridian, Idaho 83646

January 22, 2021

PROPOSED WATER DRAINAGE/REMEDATION for the crawlspace at 2875 Elisha Ave. Meridian, Idaho 83646
Ness, LLC is an IICRC council certified Mold Remediation Contractor, licensed, bonded, and insured with mold and environmental pollution endorsements

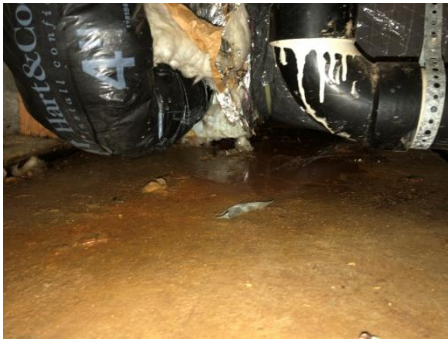
As requested, the crawlspace was inspected for standing water. There is an existing pump that does not appear to be functional as there was standing water in various areas and visible history of water intrusion. Ness would recommend cancelling the current pump and installing a drain system on the entire interior perimeter of the crawlspace. We also observed a pony wall behind the garage that is water damaged and tilted. This will need to be repaired/re-secured and mold remediation will be required. The vapor barrier will need to be replaced and we will re-secure fallen insulation and install new batts, where needed.

water in crawl under furnace

1. Cancel and remove existing drain system.
2. Install a fabric lined graded drain system below the bottom of the footings on the entire perimeter of the crawlspace except for part of the area behind the garage.
3. Drain in crawlspace will collect into a sump tank. The sump tank will be in the mid-left side of the crawlspace.

Part 3: Install sump pump into tank with insulated lid in the appropriate determined area. Sump will discharge through a drain line to a dispersal bed towards a landscaped area that will be determined onsite. (The sump pump discharge line will not be visible from the outside of the house. Installation of electrical outlet with audible alarm and manual shut-off included.)

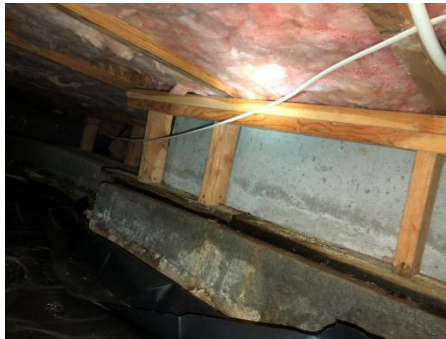
water damaged pony wall-front view

1. After containment is set up, then perform surface cleaning and abrasive removal, as needed, of visible microbial growth on the impacted pony wall and surrounding supports. (1) Once mold impacted surfaces are cleaned, then treat the remediated surfaces in the crawlspace with a non-toxic Microbial Growth Inhibitor. Procedures are established from IICRC S520 Standard and Reference Guide for Professional Mold Remediation. (2) All work in the crawlspace will be performed using accepted procedures. (3) Respiratory Protection is in accordance with the OSHA respiratory protection standard (29 CFR 1910.134) for the remediation. Gloves, full-face respirators, p-100 particulate filters, Tyvek full body suits with hoods and boots. Photo documentation of work performed is available at the end of the project upon prior request. Disposal of debris.

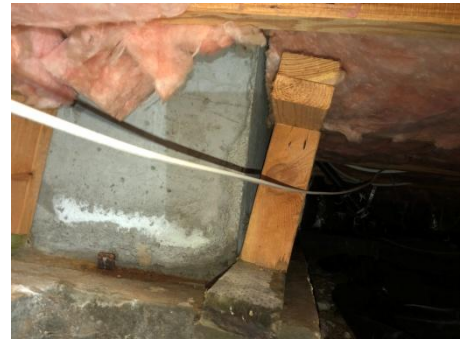
water damaged pony wall- side view- tilted
