# Ness LLC

3-26-2021

## **PROPOSED WATER DRAINAGE for the crawlspace at 3915 N. Bilberry Ave. Boise, Idaho**

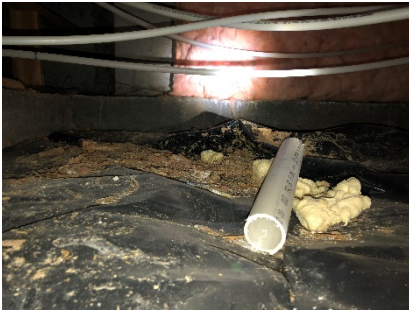
Debris under remodeled bathroom

**Part 5:** Remove and dispose of the damaged areas of the old vapor barrier, miscellaneous debris and building materials. Install new 6 mil. vapor barrier, where removed, and pull up onto the footings, where possible.

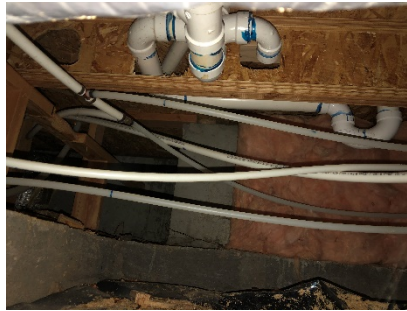
Notched for plumbing

1. Raise and level joist, as needed.
2. Install pier block and 4x4 treated post to support floor joist at weakened area under the bathroom.

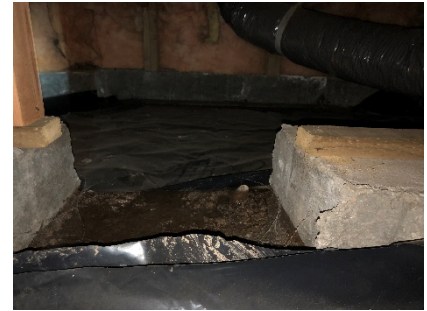
As requested, the crawlspace was inspected for standing water. Because there is standing water in some areas and evidence of seasonal intrusion, we would recommend a partial perimeter drain system with a sump pump. There did not appear to be any visible mold in the areas inspected but the view was limited due to standing water. If any microbial growth is discovered during the install, we will contact you immediately and provide a proposal for remediation at a discounted price. There is a floor joist under the remodeled bathroom that has been notched for plumbing lines. We would recommend adding a pier block and support under the floor joist to reestablish support to the area. We will re-connect the dryer duct where taping has come loose; however, we would recommend having the duct cleaned by a licensed professional. Most of the vapor barrier is in poor condition and will need to be replaced.

standing water

1. Install a fabric lined and graded drain system below the bottom of the footings along the interior perimeter of the crawlspace along the entire back and right sides and along the front right side.
2. Drain in crawlspace will collect into a sump tank. The sump tank sill be in the back right corner.

**Part 3:** Install sump pump into tank with insulated lid in the appropriate determined area. Sump will discharge through a drain line that will be trenched towards a landscaped area that will be determined onsite. (The sump pump discharge line will not be visible from the outside of the house. Installation of electrical outlet with audible alarm and manual shut off included.)
