Ness LLC

PROPOSED WATER DRAINAGE for the crawlspace at 3937 N. Bilberry Ave. Boise, Idaho

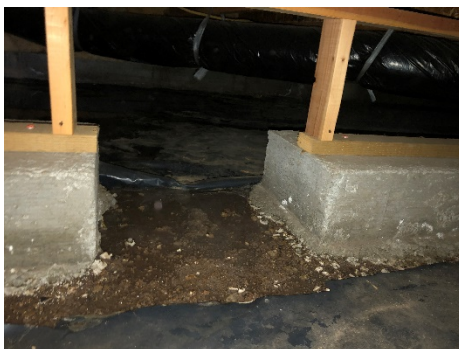
Water intrusion/Poor vapor barrier

1. Install a fabric lined and graded drain system below the bottom of the footings along the interior perimeter of the crawlspace along the entire left side and across the back left side of the crawlspace.
2. Drain in crawlspace will collect into a sump tank. The sump tank sill be in the back of the crawlspace.

Part 4: Remove and dispose of the old vapor barrier, miscellaneous debris and building materials. Install new 6 mil. vapor barrier, in the entire crawlspace, and pull up onto the footings, where possible.

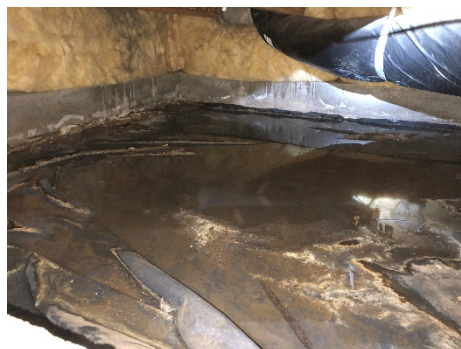
Standing water/Poor vapor barrier

Part 3: Install sump pump into tank with insulated lid in the appropriate determined area. Sump will discharge through a drain line that will be trenched towards a landscaped area that will be determined onsite. (The sump pump discharge line will not be visible from the outside of the house. Installation of electrical outlet with audible alarm and manual shut off included.)

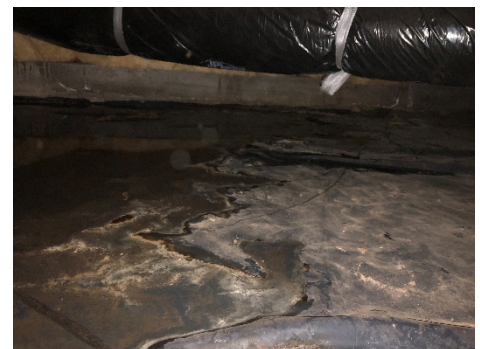
Standing water/Poor vapor barrier
