**Ness LLC Proposal for:** 2575 Sky View Lane Eagle, Idaho 83616

**March 16, 2021**

**PROPOSED WATER DRAINAGE for the crawlspace at 2575 Sky View Lane Eagle, Idaho 83616**  
**Ness, LLC is an IICRC council certified Mold Remediation Contractor, licensed, bonded, and insured with mold and environmental pollution endorsements**

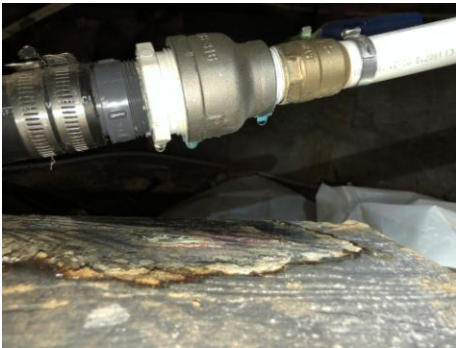
As requested, the crawl space was inspected for standing water and mold. We recommend installing a partial drain system with 2 pumps. This is based on the visual evidence that there is a history of water intrusion in some areas and standing water in others. There was also sporadic microbial growth visible on the floor decking that will require remediation. Vapor Barrier will need to be installed as well as new supports where they were cut at the access. We will remove as much of the miscellaneous debris, as possible, when installing the plastic. There is a water leak at the main connection from the outside line to the pex in the house. This will need to be repaired by a licensed plumbing professional in order to maintain our warranties.

active leak

**Part 3:** Install sump pumps into tanks with insulated lids in the appropriate determined areas. The front sump will discharge through a drain line to the tank in back. The discharge for the tank in the back will need to be determined onsite. (The sump pump discharge line will not be visible from the outside of the house. Installation of electrical outlet with audible alarm and manual shut-off included.)

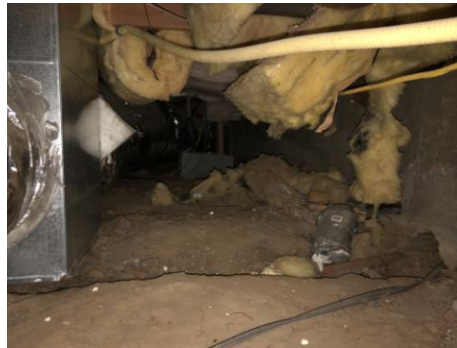
misc. debris and missing vapor barrier

**Part 8:** Remove and dispose of old vapor barrier, miscellaneous debris, and building materials. Install new 6 mil. vapor barrier in the entire crawlspace and pull up onto the footings, where possible.

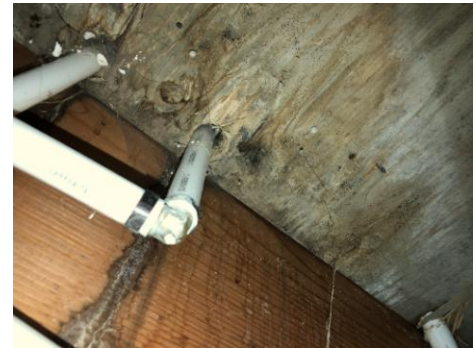
mold on floor decking

1. After containment is set up, then perform surface cleaning and abrasive removal, as needed, of visible microbial growth on the impacted floor decking. Once mold impacted surfaces are cleaned, then treat the remediated surfaces in the crawlspace with a non-toxic Microbial Growth Inhibitor. Procedures are established from IICRC S520 Standard and Reference Guide for Professional Mold Remediation. (2) All work in the crawlspace will be performed using accepted procedures. (3) Respiratory Protection is in accordance with the OSHA respiratory protection standard (29 CFR 1910.134) for the remediation. Gloves, full-face respirators, p-100 particulate filters, Tyvek full body suits with hoods and boots. Photo documentation of work performed is available at the end of the project upon prior request. Disposal of debris.
