Ness LLC

PROPOSED WATER DRAINAGE and REMEDIATION for the crawlspace at 982 N. Triathlon Ave. Eagle, Idaho 83616
Ness, LLC is an IICRC council certified Mold Remediation Contractor, licensed, bonded, and insured with mold and environmental pollution endorsements.

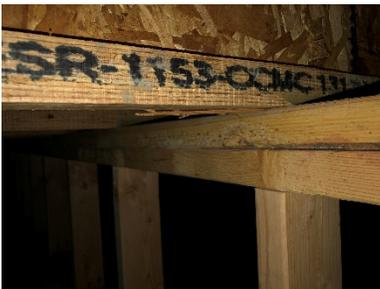
As requested, the crawlspace was inspected for standing water. Because there is water intrusion in most of the crawlspace, we would recommend installing a perimeter drain system with two sump pumps. There was visible mold on the pony walls and some joists that will require remediation. The vapor barrier will also need to be replaced.

Visible mold

Part 5: Microbial Growth Remediation Compliance

1. After containment is set up, then perform surface cleaning and abrasive removal, as needed, of visible microbial growth on the impacted pony walls and joists. Once mold impacted surfaces are cleaned, then treat the remediated surfaces in the crawlspace with a non-toxic Microbial Growth Inhibitor. Procedures are established from IICRC S520 Standard and Reference Guide for Professional Mold Remediation. (2) All work in the crawlspace will be performed using accepted procedures. (3) Respiratory Protection is in accordance with the OSHA respiratory protection standard (29 CFR 1910.134) for the remediation. Gloves, full-face respirators, p-100 particulate filters, Tyvek full body suits with hoods and boots. Photo documentation of work performed is available at the end of the project upon prior request. Disposal of debris.

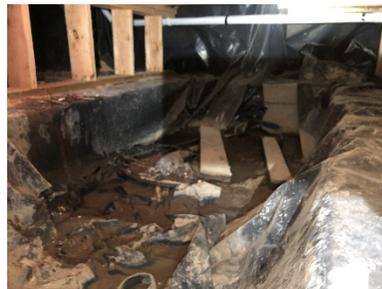
Standing Water/Poor Vapor Barrier

1. Install a fabric lined and graded drain system below the bottom of the footings along the entire interior perimeter of the crawlspace except for behind part of the garage.
2. Drain in crawlspace will collect into two sump tanks. One sump tank will be in the mid-left side of the crawlspace and the other will be installed in the mid-right side.

Part 7: Remove and dispose of vapor barrier, miscellaneous debris, and building materials. Install new 6 mil. vapor barrier in the entire crawlspace and pull up onto the footings, where possible. All seams will be taped per code for a conditioned crawlspace.

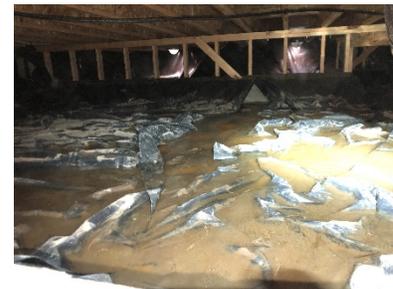
Standing Water/Poor Vapor Barrier
