Ness LLC Proposal for: 2116 W. Preston St. Eagle, Idaho 83616

April 22, 2021

PROPOSED WATER DRAINAGE and REMEDIATION for the crawlspace at 2116 W. Preston St. Eagle, Idaho 83616
Ness, LLC is an IICRC council certified Mold Remediation Contractor, licensed, bonded, and insured with mold and environmental pollution endorsements

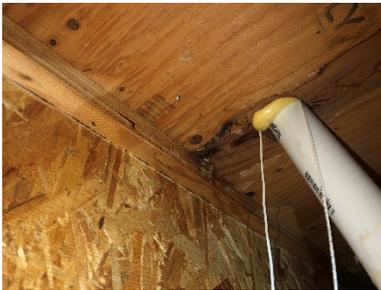
As requested, the crawl space was inspected for standing water. We recommend installing a partial drain system with 2 pumps. This is based on the visual evidence that there is a history of water intrusion in some areas and standing water in others. There was also sporadic microbial growth visible on the floor decking, pony walls and floor joists that will require remediation. Some of the vapor barrier is in poor condition and some is in fair condition. We will replace the plastic, where needed, and redistribute the existing plastic in other areas.

Microbial growth

1. After containment is set up, then perform surface cleaning and abrasive removal, as needed, of visible microbial growth on the impacted floor decking, pony walls and floor joists. Once mold impacted surfaces are cleaned, then treat the remediated surfaces in the crawlspace with a non-toxic Microbial Growth Inhibitor. Procedures are established from IICRC S520 Standard and Reference Guide for Professional Mold Remediation. (2) All work in the crawlspace will be performed using accepted procedures. (3) Respiratory Protection is in accordance with the OSHA respiratory protection standard (29 CFR 1910.134) for the remediation. Gloves, full-face respirators, p-100 particulate filters, Tyvek full body suits with hoods and boots. Photo documentation of work performed is available at the end of the project upon prior request. Disposal of debris.

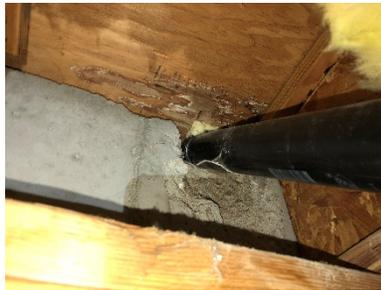
Microbial growth

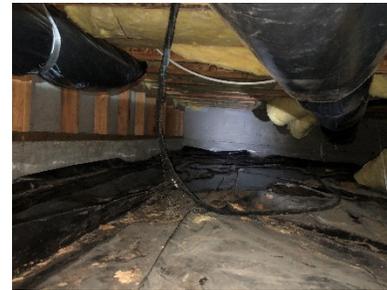
Standing water

1. Install a fabric lined graded drain system below the bottom of the footings on the inside perimeter of the crawlspace in the back of the right wing and the back of the left wing.
2. Drains in crawlspace will collect into two sump tanks. One sump tank will be in the back middle area of the left wing and the other will be in the back right side.

Part 3: Install sump pumps into tanks with insulated lids in the appropriate determined areas. The discharge for both pumps will be directed towards a landscaped area that will be determined onsite. (The sump pump discharge line will not be visible from the outside of the house. Installation of electrical outlet with audible alarm and manual shut-off included.)
