Ness LLC Proposal for: 639 S. Truss Ave. Meridian, Idaho 83642

May 3, 2021

PROPOSED WATER DRAINAGE/REMEDIATION for the crawlspace at 639 S. Truss Ave. Meridian, Idaho 83642
Ness, LLC is an IICRC council certified Mold Remediation Contractor, licensed, bonded, and insured with mold and environmental pollution endorsements

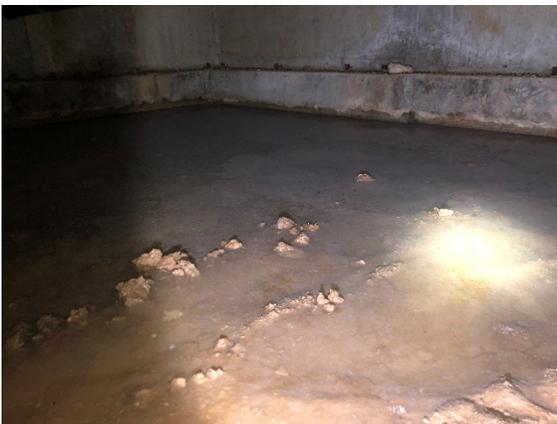
As requested, the crawlspace was inspected for water intrusion issues. We observed standing water over a foot deep in a large portion of the crawlspace and evidence of a history of water intrusion in other areas. We would recommend installing a drain system with a sump pump. Mold was also discovered on the rim joist in the entire right half of the crawlspace that will need remediation. The vapor barrier is in poor condition and missing completely in a large portion of the crawlspace. We will install new vapor barrier once the water is controlled, and the mold is remediated.

1.5 ft standing water in the crawlspace

1. All access to crawlspace surfaces will be protected by plastic sheeting during work.
2. Preliminary digging and pumping to remove excess water, as needed.
3. Negative air machine used for the crawlspace during work and for dry down.
4. Additional fans will be installed for dry down, as needed.
5. Clear foundation vents of any insulation that may be blocking air flow.

1. Install a fabric lined graded drain system below the bottom of the footings on the entire perimeter of the crawlspace except for part of the area behind the garage.

2. Drain in crawlspace will collect into a sump tank. The sump tank will be in the back middle area of the crawlspace.

Part 3: Install sump pump into tank with insulated lid in the appropriate determined area. Sump will discharge through a drain line towards a dispersal bed in the front-right landscaped area. (The sump pump discharge line will not be visible from the outside of the house. Installation of electrical outlet with audible alarm and manual shut-off included.)

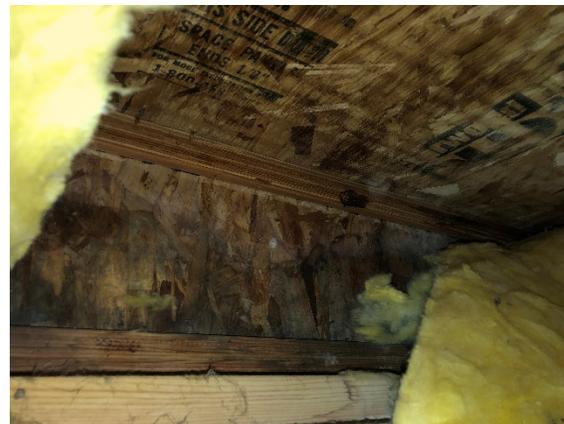
mold on the rim joist

1. After containment is set up, then perform surface cleaning and abrasive removal, as needed, of visible microbial growth on the impacted rim joist. (1) Once mold impacted surfaces are cleaned, then treat the remediated surfaces in the crawlspace with a non-toxic Microbial Growth Inhibitor. Procedures are established from IICRC S520 Standard and Reference Guide for Professional Mold Remediation. (2) All work in the crawlspace will be performed using accepted procedures. (3) Respiratory Protection is in accordance with the OSHA respiratory protection standard (29 CFR 1910.134) for the remediation. Gloves, full-face respirators, p-100 particulate filters, Tyvek full body suits with hoods and boots. Photo documentation of work performed is available at the end of the project upon prior request. Disposal of debris.
