Ness LLC

PROPOSED Drywell in backyard at 2087 E. Melwood St. Meridian, Idaho 83642

ADDRESS: 2087 E. Melwood St Meridian

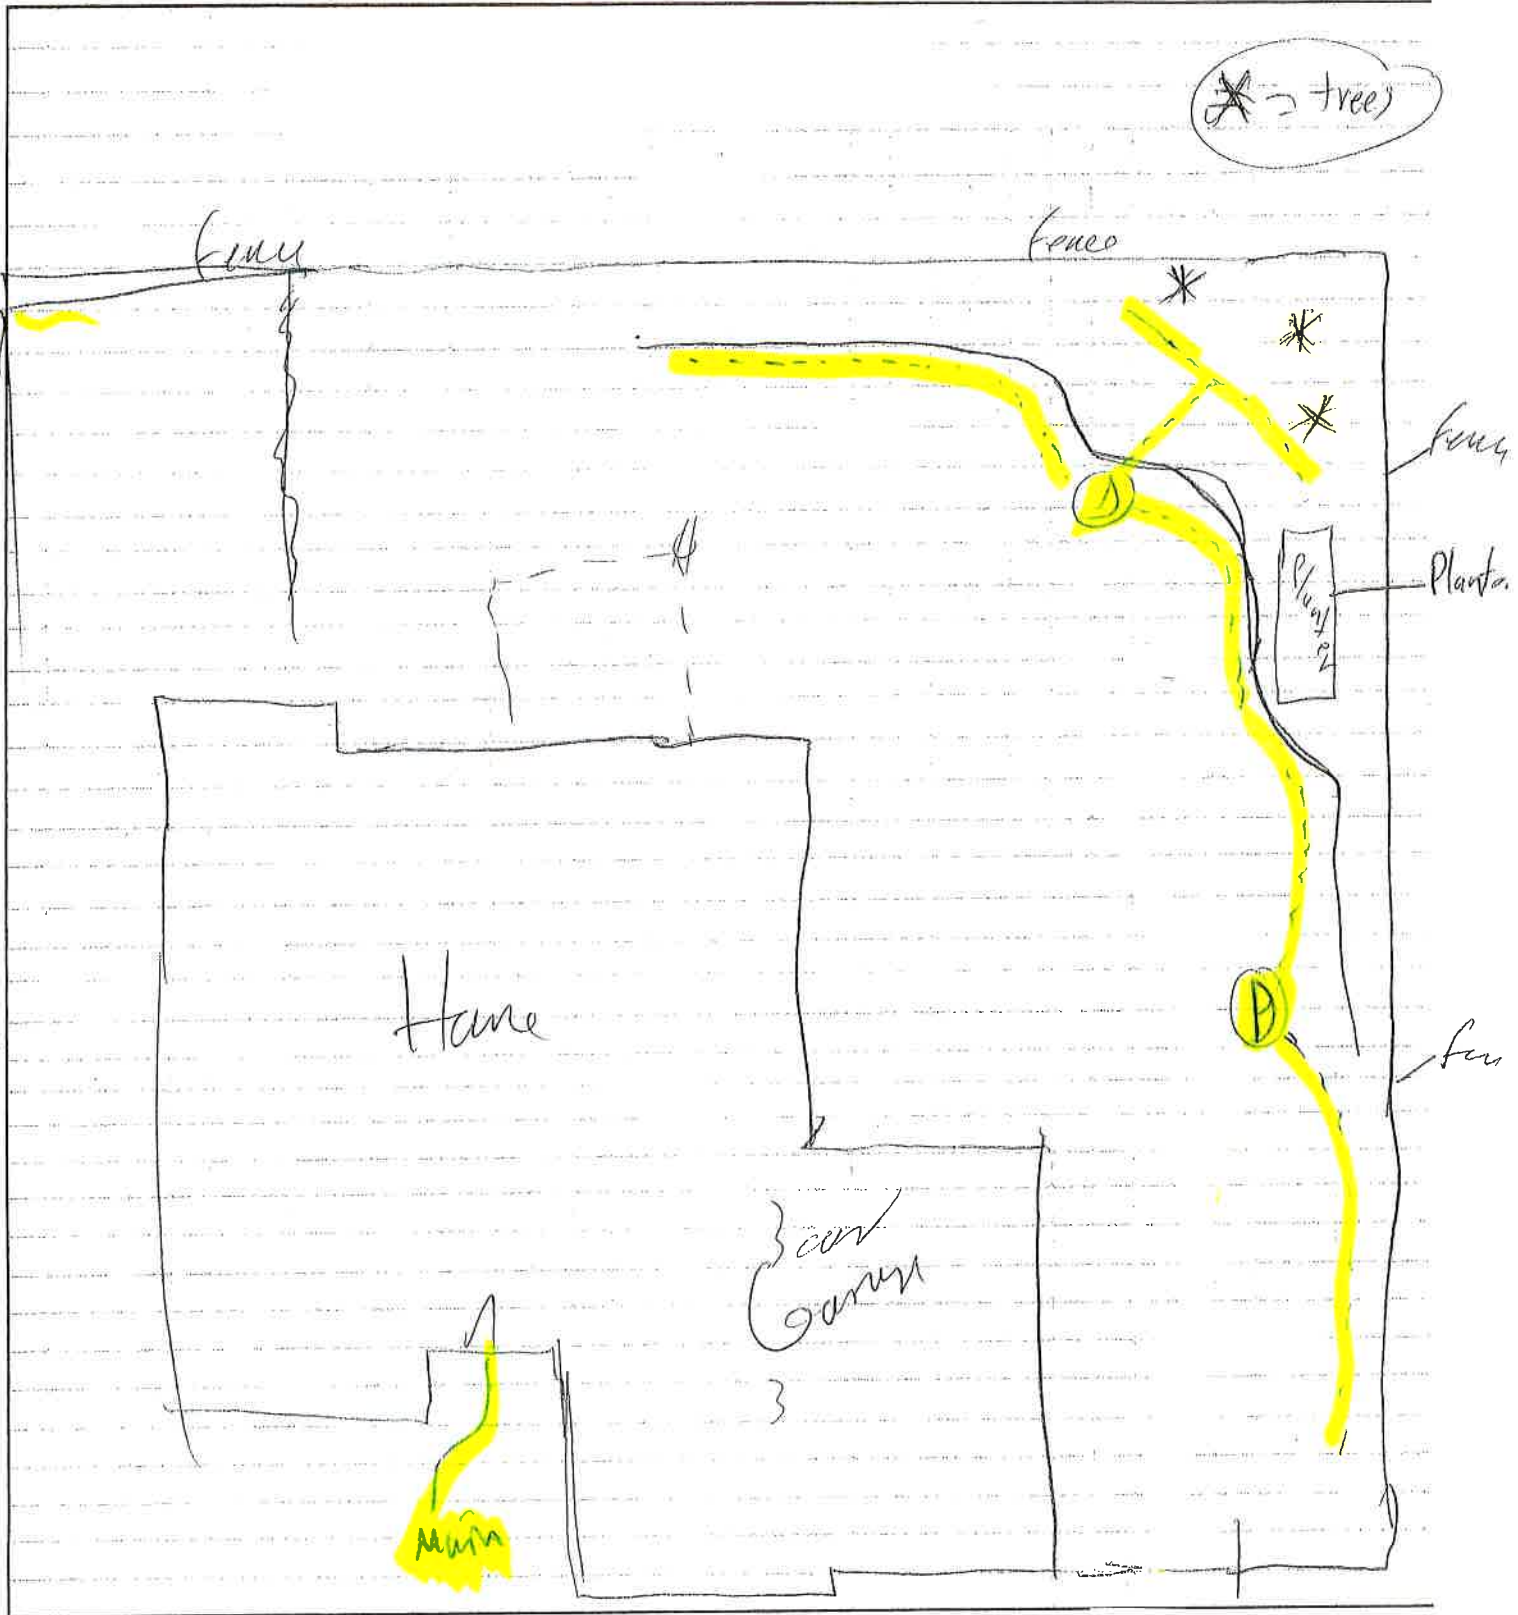
Part 1: Install drywells and drains system on the right side of the home. See attached sketch.

4. Trenches will be lined before installing perforated pipe.
5. Perforated pipe to be secured with landscaping cinders and sandy soil.
6. Connect trenching to drywells: One drywell will be in the middle of the right side and the other will be in the back-right corner in front of the rock bed where the trees are planted.

There is an apparent clay layer of soil at the back right corner of the property that is not allowing water to drain and creating standing water. We would recommend installing two drywells on the right side of the yard. One will be in the back corner and the other will be in the middle of the right side. Trenches will be dug down the entire right side and part of the back on the right side. Additional trenches will be added in front of the trees in the back corner. All trenches will be graded and connected so excess water will discharge to the drywells where it can dissipate in the drainable soil.
