**Ness LLC Proposal for:** 630 Autumn Pl. Nampa, Idaho 83686

7-2-2021

## PROPOSED WATER DRAINAGE for the Crawlspace at 630 Autumn Pl. Nampa, Idaho 83686

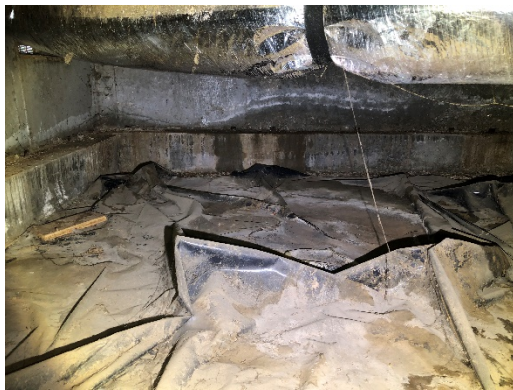
As requested, the crawlspace was inspected for water intrusion. There was no standing water at the time of our inspection but there is visible evidence of a history of water intrusion. We would recommend installing an interior drain system to control the water before mold develops. We did not observe any mold, but the view was limited. If any microbial growth is discovered during the drain install, you will be notified immediately, and a discounted proposal will be written up for remediation. The vapor barrier is in poor condition and will need to be replaced.

Water lines at cold joint from repeat intrusion

1. Install a fabric lined graded drain system below the bottom of the footings along the entire interior perimeter of the crawlspace except for behind the garage and the main entrance.
3. Drain in crawlspace will collect into a sump tank. The sump tank will be in the middle of the right side.

**Part 3:** Install sump pump into tank with insulated lid in the appropriate determined area. Sump will discharge through a drain line to a dispersal bed towards a landscaped area that will be determined onsite. (The sump pumps discharge line will not be visible from the outside of the house. Installation of electrical outlet with audible alarm and manual shut-off included.)

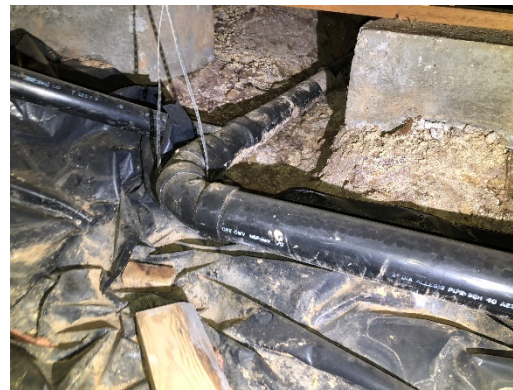
Mineral build up from repeated intrusion/drying
