# Ness LLC

11-8-2021

## **PROPOSED WATER DRAINAGE for the crawlspace at 3915 N. Bilberry Ave. Boise, Idaho**

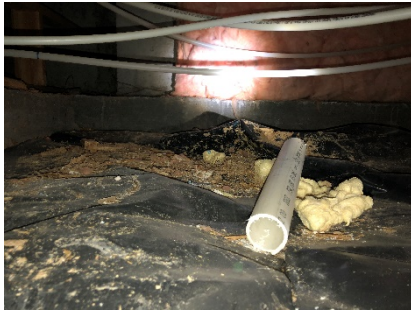
Debris under remodeled bathroom

**Part 5:** Remove and dispose of the damaged areas of the old vapor barrier, miscellaneous debris and building materials. Install new 6 mil. vapor barrier, where removed, and pull up onto the footings, where possible.

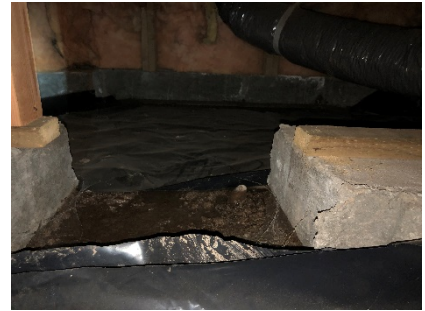
As requested, the crawlspace was inspected for standing water. Because there is standing water in some areas and evidence of seasonal intrusion, we would recommend a partial perimeter drain system with a sump pump. There did not appear to be any visible mold in the areas inspected but the view was limited due to standing water. If any microbial growth is discovered during the install, we will contact you immediately and provide a proposal for remediation at a discounted price. There is a floor joist under the remodeled bathroom that has been notched for plumbing lines. We would recommend adding a pier block and support under the floor joist to reestablish support to the area. We will re-connect the dryer duct where taping has come loose; however, we would recommend having the duct cleaned by a licensed professional. Most of the vapor barrier is in poor condition and will need to be replaced.

standing water

1. Install a fabric lined and graded drain system below the bottom of the footings along the interior perimeter of the crawlspace along the entire back and right sides and along the front right side.
2. Drain in crawlspace will collect into a sump tank. The sump tank will be in the back right corner.

**Part 3:** Install sump pump into tank with insulated lid in the appropriate determined area. Sump will discharge through a drain line that will be trenched towards a landscaped area that will be determined onsite. (The sump pump discharge line will not be visible from the outside of the house. Installation of electrical outlet with audible alarm and manual shut off included.)
